"Open-cell" implementation of a trenched DMOS
power transistor (CALMA hard copy, active region).
Siliconix, Inc., 1987.

"Closed-cell" implementation of a trench DMOS power transistor (CALMA hard copy, active region).
Siliconix, Inc., 1987.

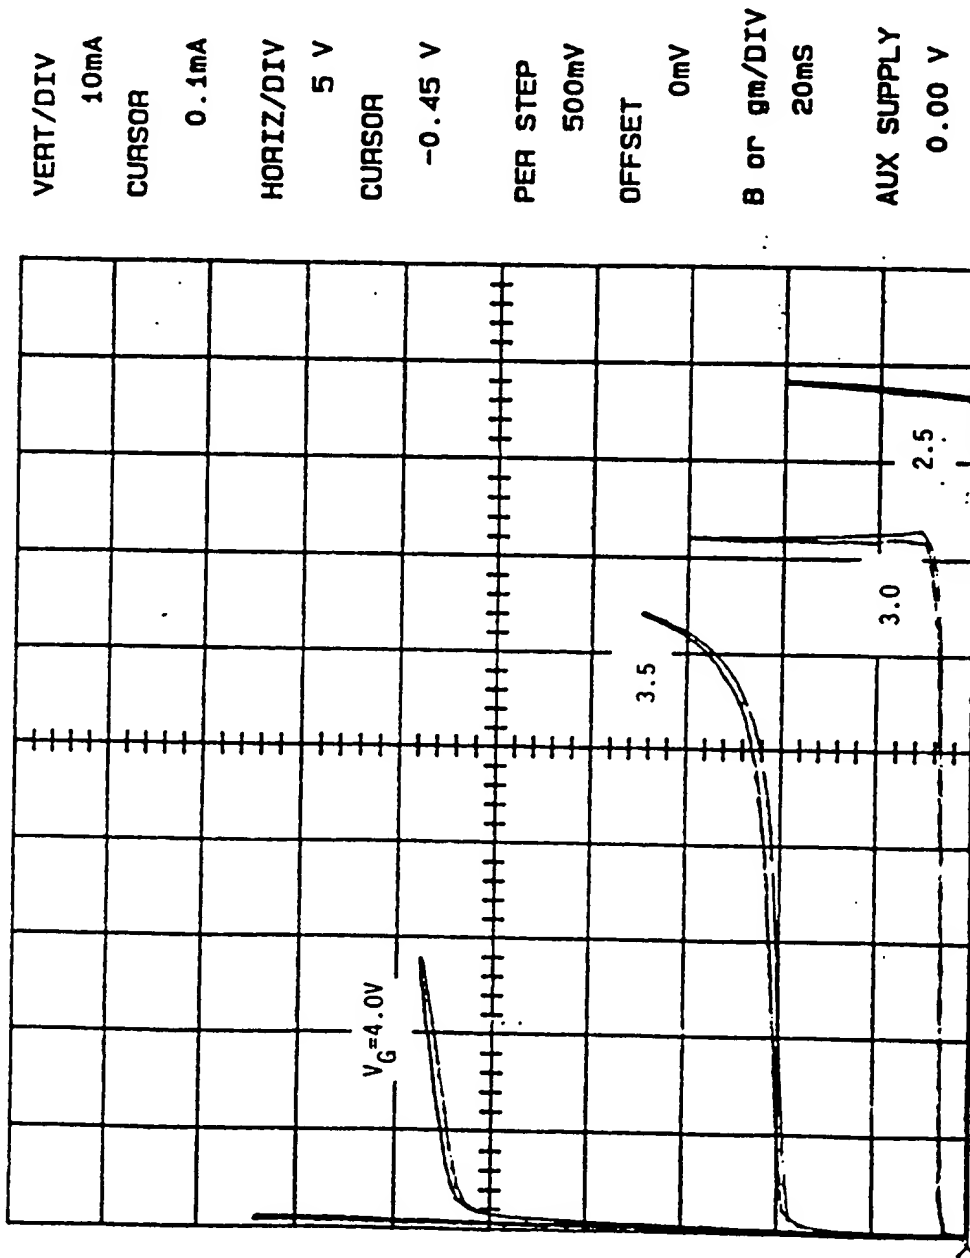
Figure 3,a

Output I-V characteristics of an experimental "open-cell" trench MOS transistor having distant body contacts, perpendicular to the trenches. Siliconix, Inc., 1988.

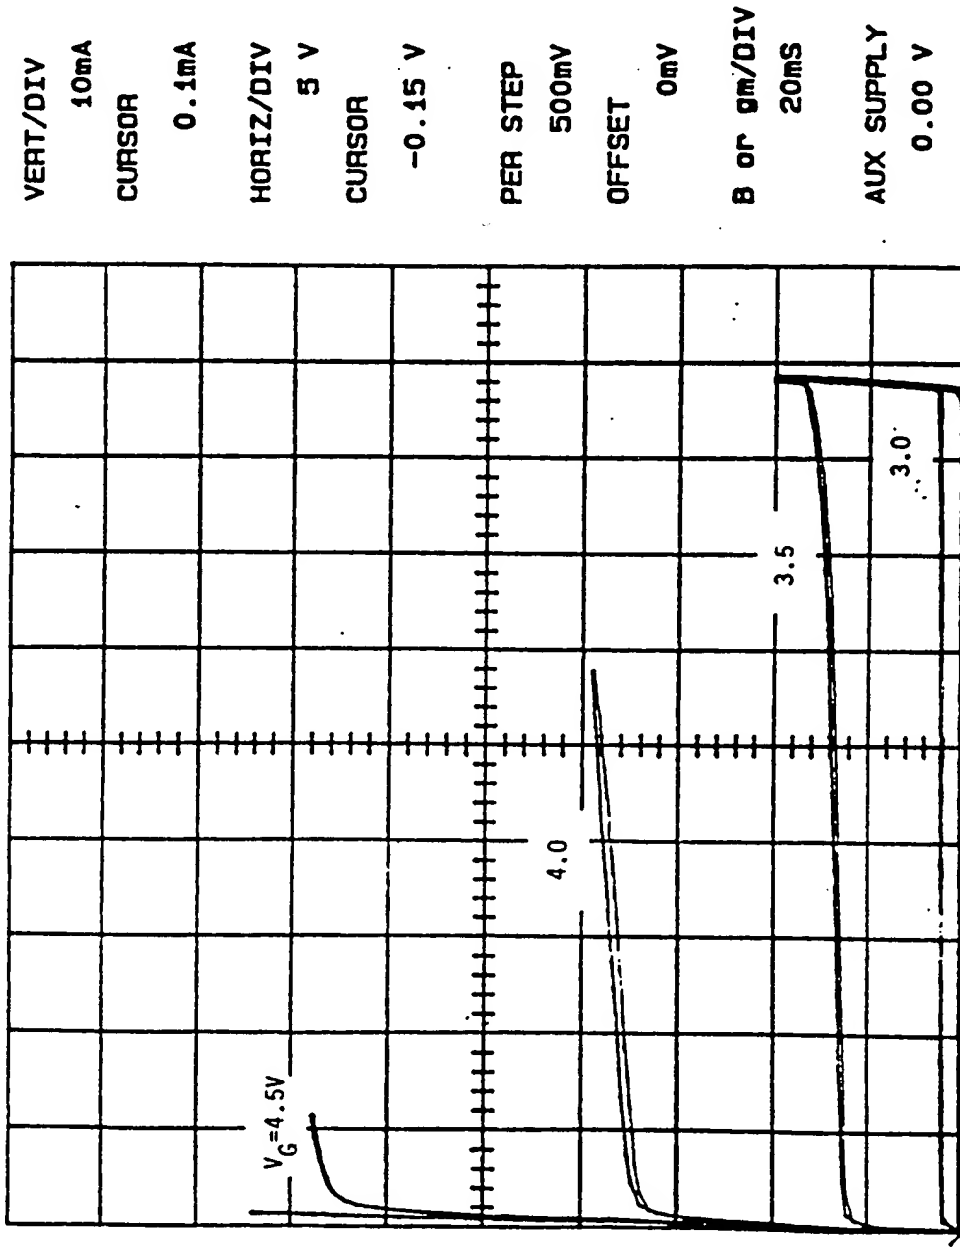
Figure 3,b

Output I-V characteristics of an experimental "open-cell" transistors having closely-spaced body contacts, perpendicular to the trenches. Siliconix, Inc., 1988.

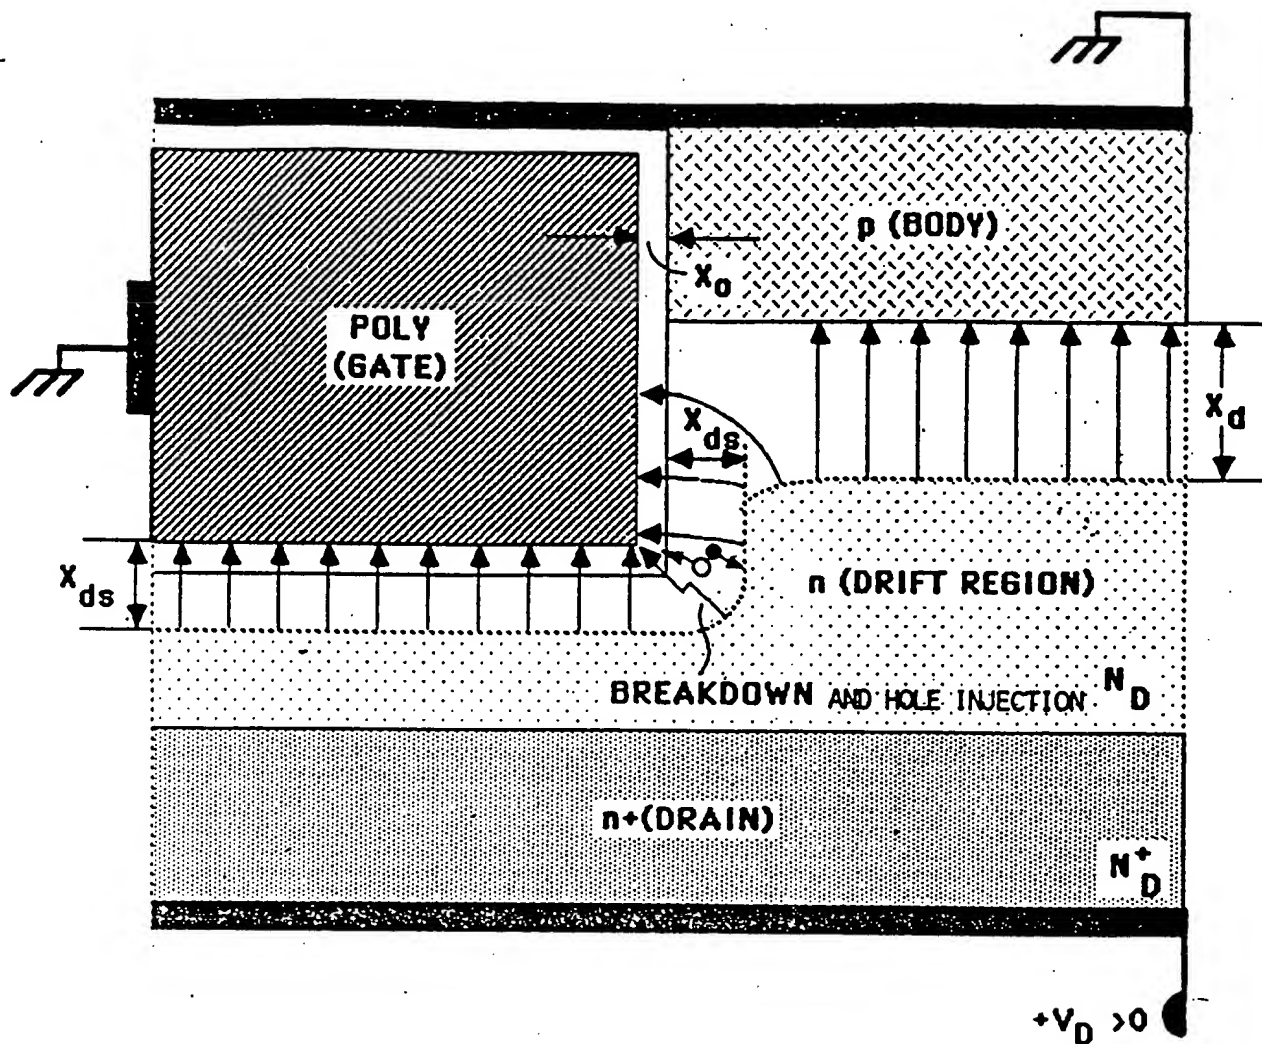
Figure 4 (PRIOR ART)

Qualitative description of the electric-field structure in a trench DMOS transistor having no deep-body profile provision. BVDSS biasing, source junction omitted.

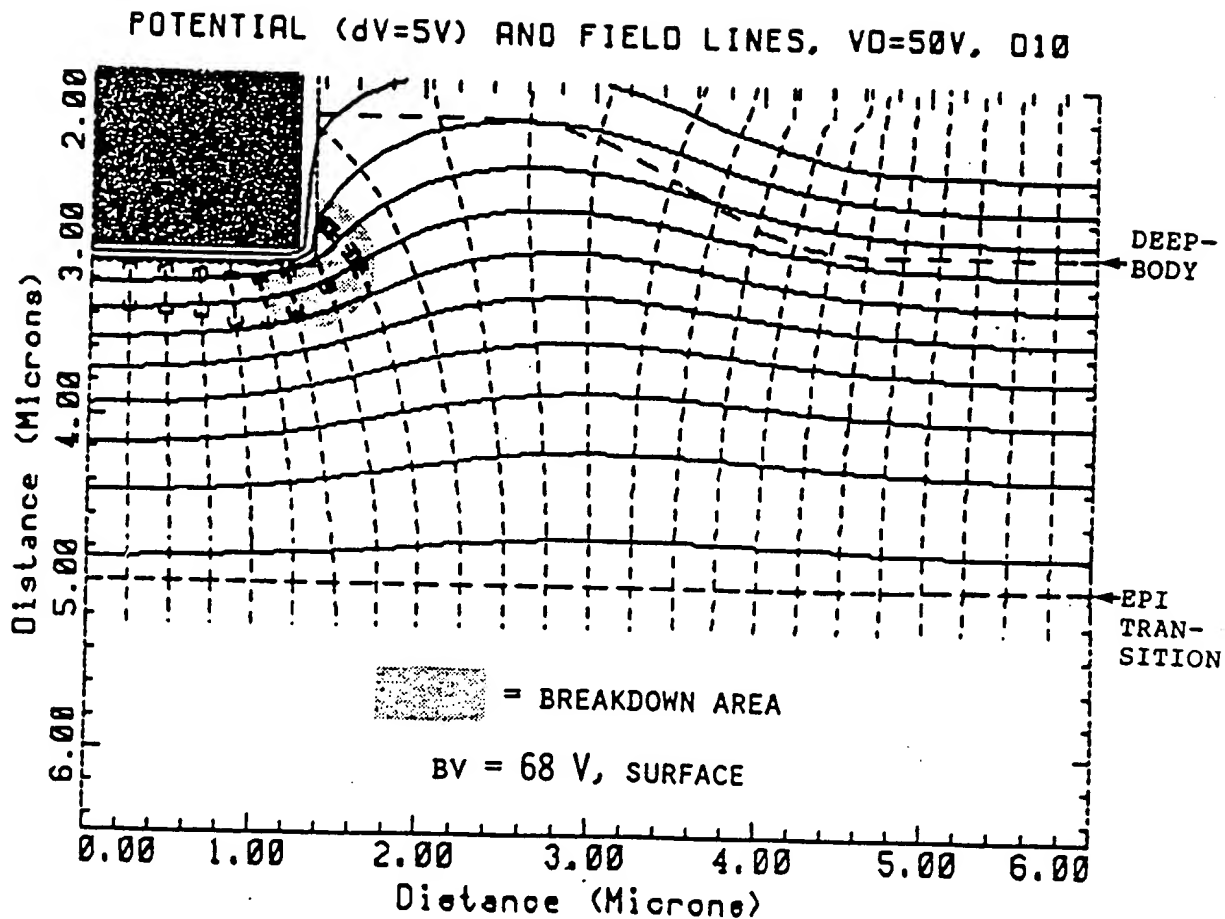
Figure 5 (PRIOR ART)

2-D computer simulation of the BVDSS operation of a trench MOS transistor having the deep body junction shallower than the trench. Drain breakdown takes place beneath the trench surface.

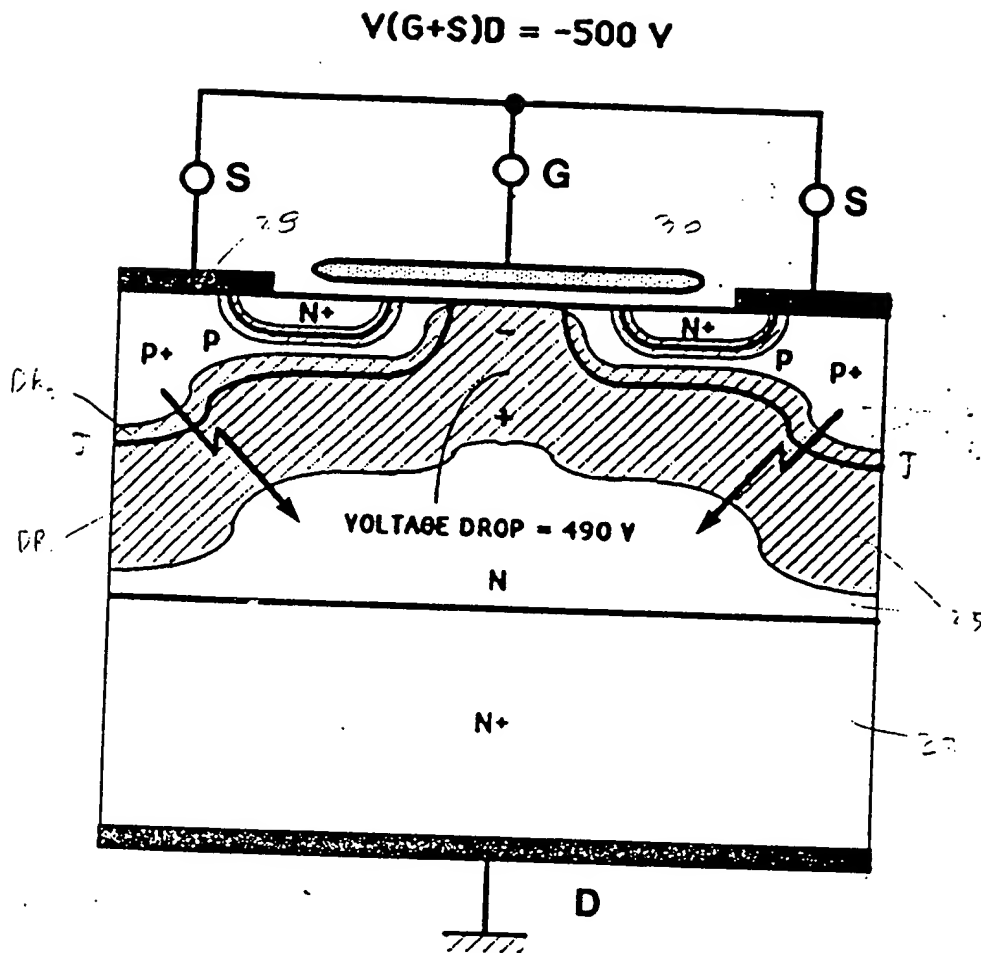
Figure 6 (PRIOR ART)

Junction and depletion-region topology
of a planar DMOS transistor biased in the BVDSS condition.

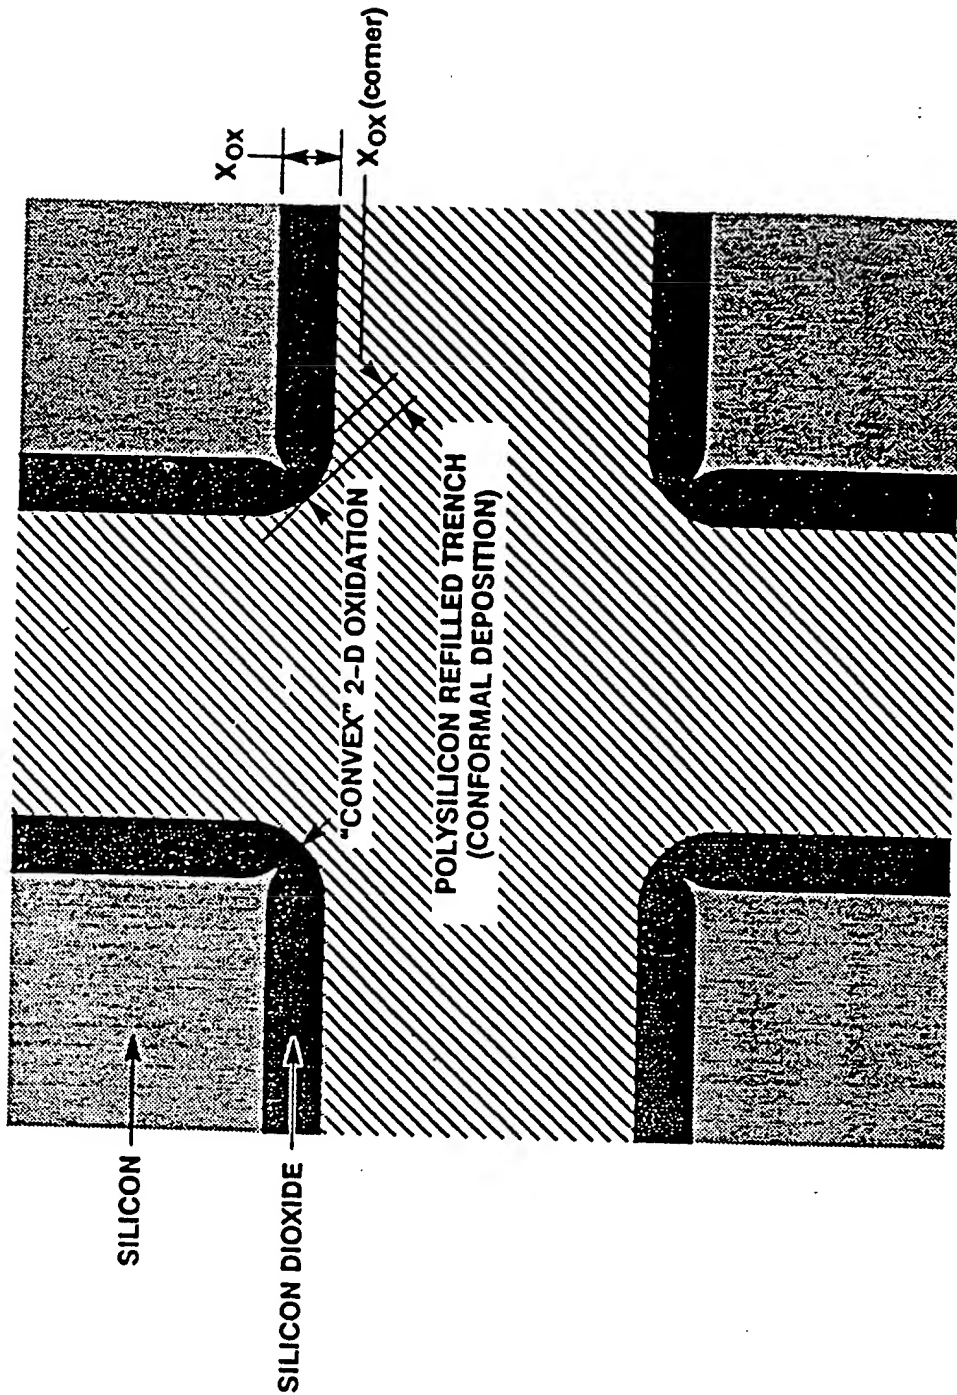
Figure 7 (Prior Art)
Qualitative description of the oxide profile
at a rectangular trench intersection.
